# Mobile Intel® Celeron® Processor on .13 Micron Process in Micro-FCPGA Package

Specification Update

Document Number: 251309-010

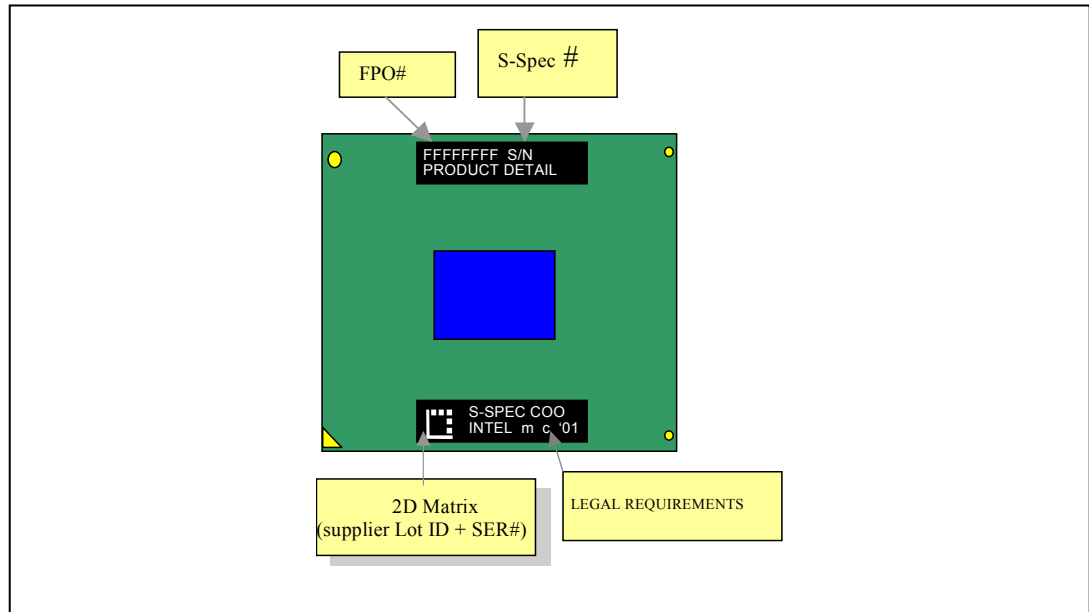
Figure 1. Mobile Intel® Celeron® Processor on .13 Micron Process (Micro-FCPGA) Markings
